FIELD STUDY

# 75W-90 Long Life Synthetic Gear Lube Study in Over-the-Road Applications

Demonstrate that AMSOIL 75W-90 Long Life Synthetic Gear Lube meets or exceeds the increased performance needs of differentials installed in heavy-duty, long-haul fleet applications practicing 500,000-mile drain intervals.

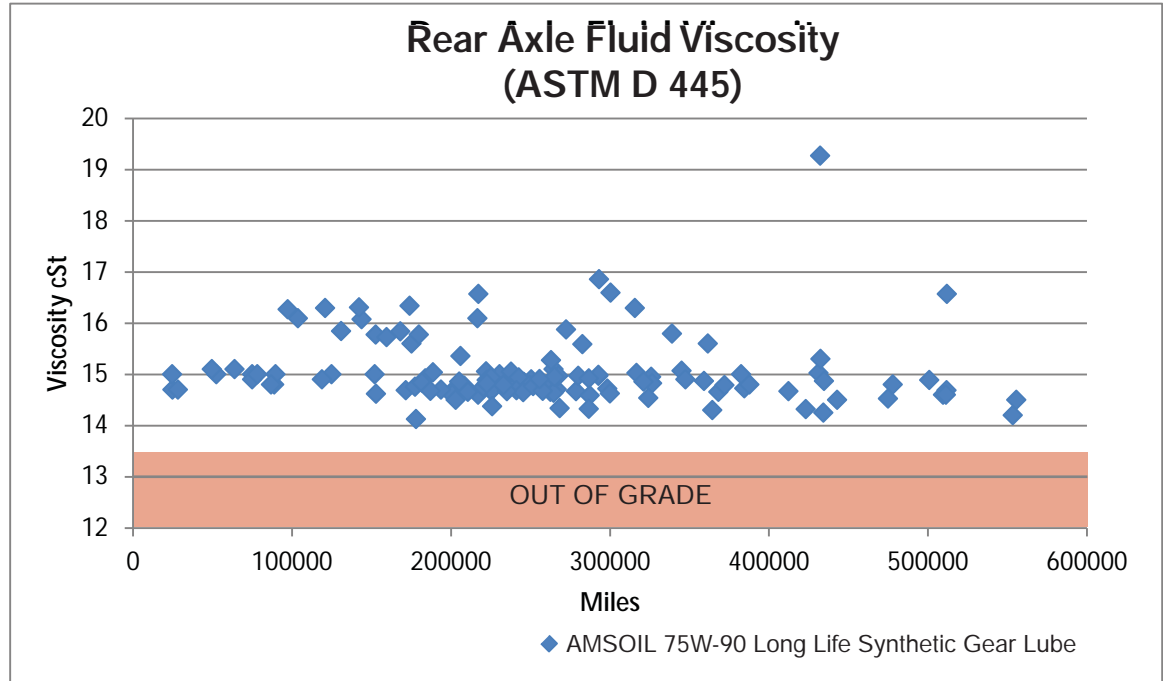
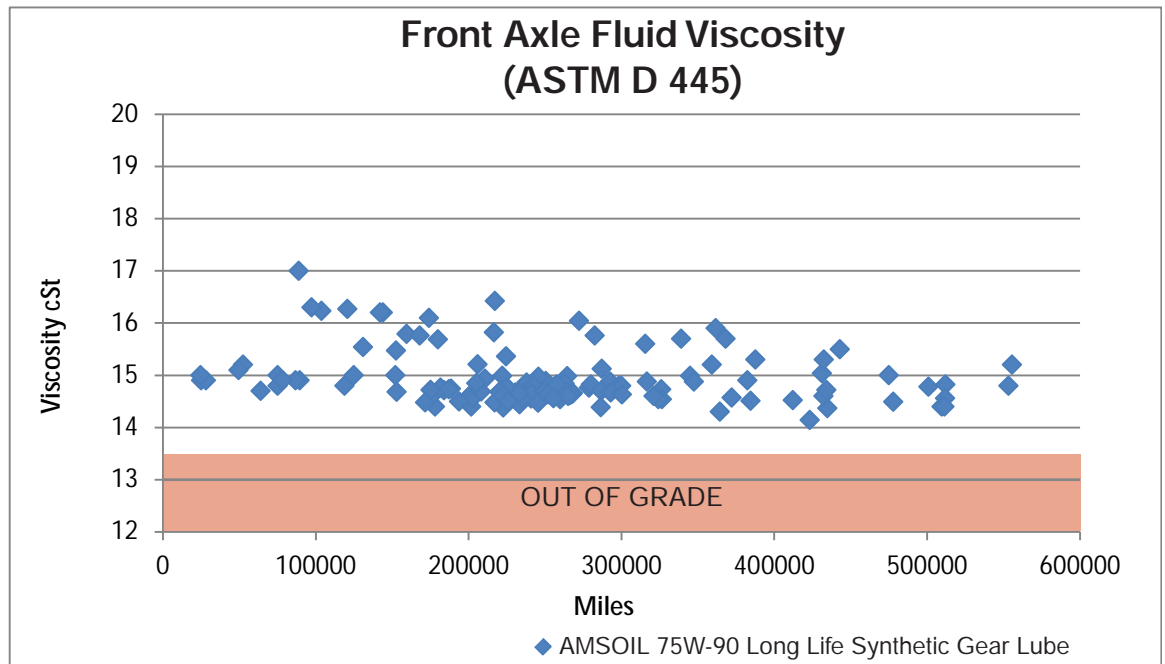
## Oil Analysis – Viscosity Retention

Oil analysis indicated that, on average, AMSOIL 75W-90 Long Life Synthetic Gear Lube demonstrated only 9.3 percent viscosity loss in the rear axle and 10 percent loss in the front throughout the field study. The lubricant remained above the 13.5 cSt viscosity limit for 75W-90 gear lube in all instances, confirming its ability to resist shear and maintain its protective lubricating film even after 500,000 miles in service.

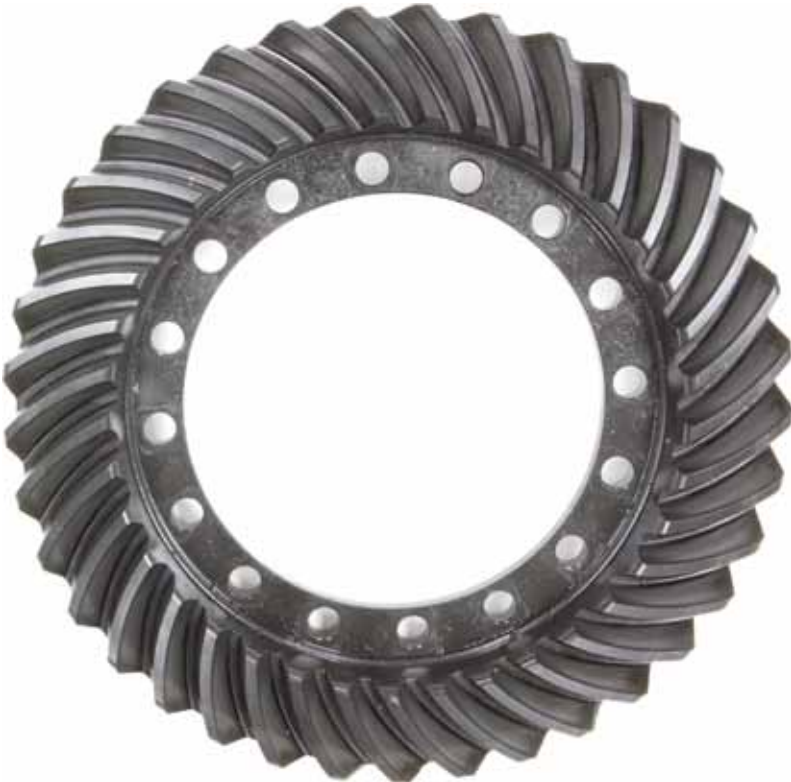
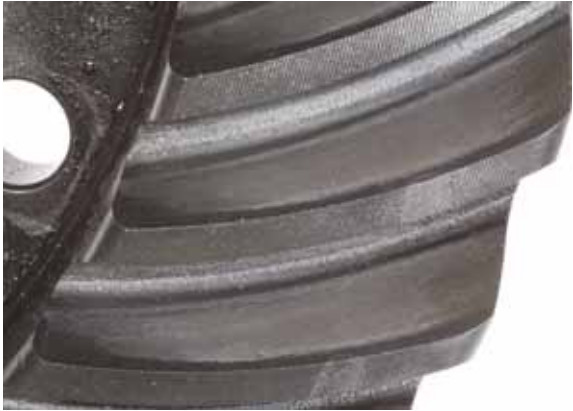
**Front Axle Ring Gear**

Condition	Drive Side	Coast Side
Burnish	Dull	Dull
Wear	9	9
Rippling	10	10
Ridging	10	10
Pitting	10	10
Spalling	10	10
Scoring	10	10
Discoloration	9	9
Corrosion	10	10

Merit ratings for burnish are represented by qualitative terms ranging from *dull* to *brightly polished*. Greater levels of wear to gear teeth are denoted by brighter levels of burnish. Despite intense pressure and shock-loading conditions that can rupture the lubricant’s fluid film, inviting wear, the ring gear demonstrated only *dull* burnish. AMSOIL 75W-90 Long Life Synthetic Gear Lube also prevented rippling, ridging, pitting, spalling, scoring and discoloration. Wear was inhibited to a *trace* level, indicating the lubricant excelled in limiting metal-to-metal contact.

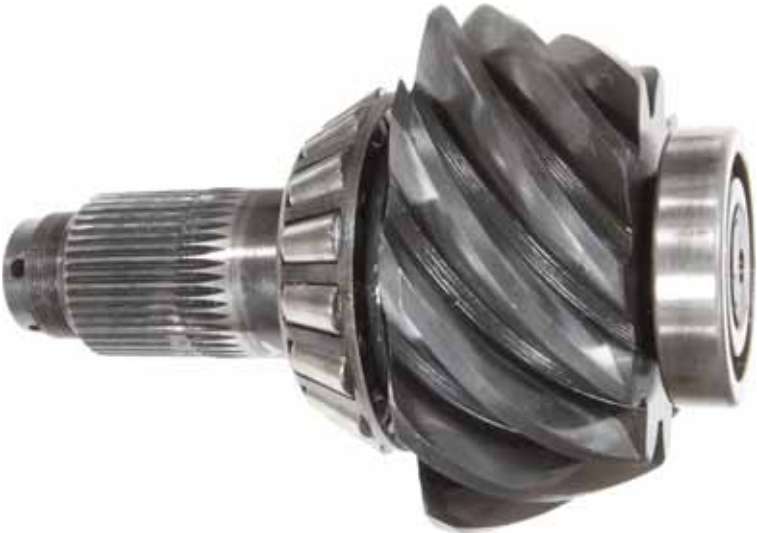
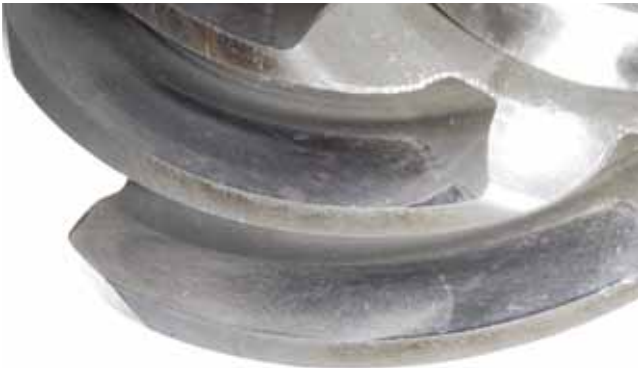
### Front Axle Pinion Gear

Condition	Drive Side	Coast Side
Burnish	Medium Bright	Medium Bright
Wear	8	9
Rippling	10	10
Ridging	10	10
Pitting	10	10
Spalling	10	10
Scoring	10	10
Discoloration	9	9
Corrosion	10	10

The pinion gear earned perfect 10 merit ratings in six of eight applicable categories, while the lubricant limited wear despite the challenging operating conditions. The gear ratio (3.36:1) indicates each tooth on the pinion gear engages in contact 3.36 times more often than each tooth on the mating ring gear. The increased stress explains why the pinion gear earned a lower burnish rating (*medium bright*) compared to the front axle ring gear.

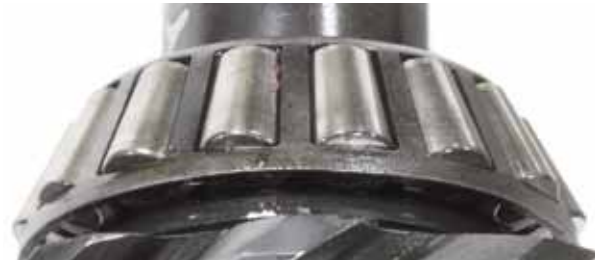
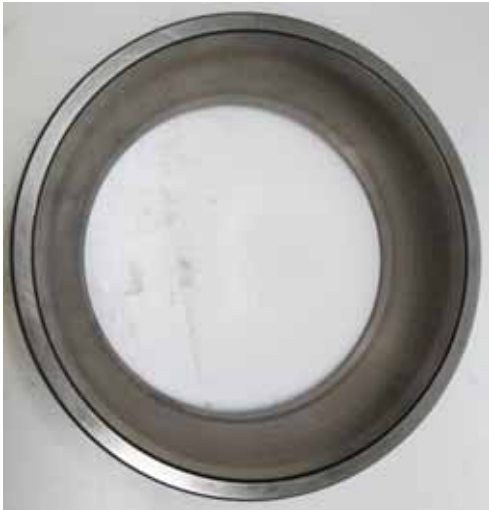
**Front Axle Pinion Bearing**

Condition	Cup	Rollers
Wear	8	8
Scoring	10	10
Pitting	8 <sup>1</sup>	8 <sup>1</sup>
Spalling	10	10
Discoloration	8	7
Corrosion	10	10
Roller End Wear	NR	7

<sup>1</sup>Debris denting, not pitting

Constant rotational stress, often under heavy load, results in elevated friction and heat that can shorten bearing life. The pinion bearing cup and rollers demonstrated no scoring, spalling or corrosion, while the lubricant limited wear to a *trace-light* level. AMSOIL 75W-90 Long Life Synthetic Gear Lube provided excellent protection.

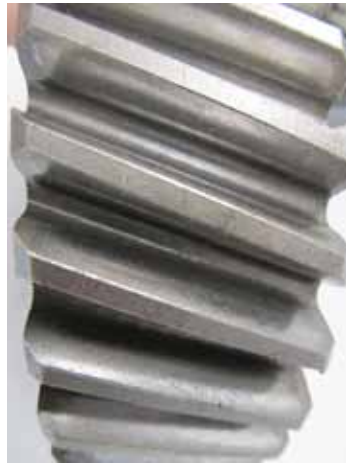
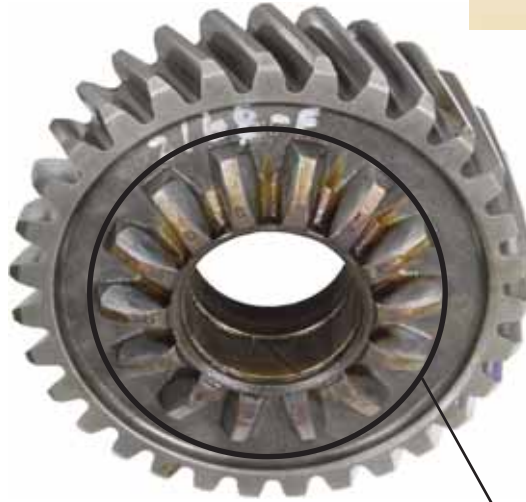
## Front Axle Helical Gears & Thrust Washer

Condition	Helical Drive Gear	Helical Driven Gear	Side Gear	Output Shaft Side Gear	Thrust Washer
<b>Burnish</b>	Medium Bright	Bright	Bright	Bright	NR
<b>Wear</b>	7	7	6	7	7
<b>Sludge</b>	6	8	6	7	6
<b>Ridging</b>	NR	8	NR	NR	NR
<b>Rippling</b>	NR	9	NR	NR	NR
<b>Pitting</b>	8	NR	7	7	7
<b>Spalling</b>	NR	NR	7	9	NR
<b>Discoloration</b>	NR	NR	NR	NR	8

The front axle helical gears are engaged by the driver to connect the front and rear axles when added traction is needed. The design of helical gears allows them to bear increased loads and operate more quietly than other gear designs; however, increased loads also invite increased distress. AMSOIL 75W-90 Long Life Synthetic Gear Lube limited wear to both the helical drive gear and helical driven gear to a *light* level. The lubricant also inhibited burnish, ridging and pitting effectively. The side gear, located on the front of the helical driven gear, and the output shaft side gear also demonstrated a high level of protection.

By nature, the angular cut of helical gear teeth causes the gears to move outward during operation. The thrust washer absorbs the motion, creating wear conditions. AMSOIL 75W-90 Long Life Synthetic Gear Lube controlled wear to a *light* level, confirming the level of protection the lubricant provided.

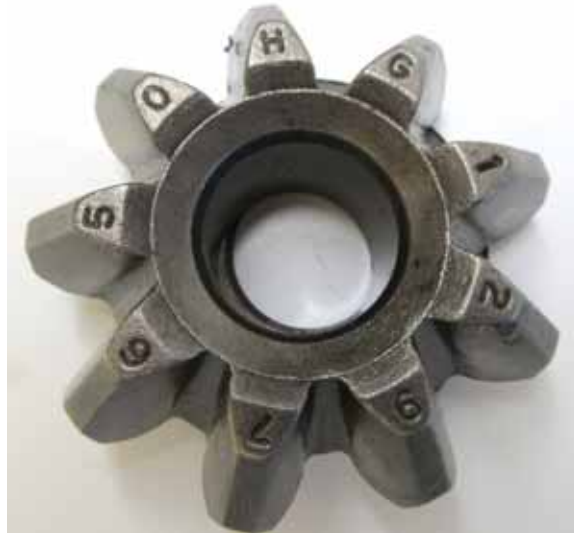
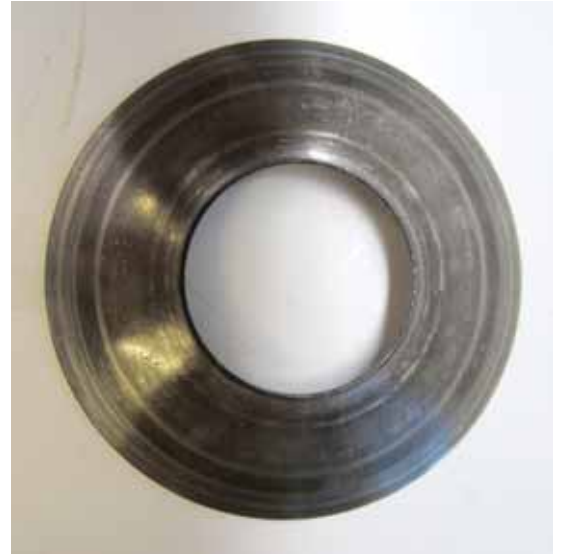
## Front Axle Spider Gears & Thrust Washers

Condition	Spider Gear	Thrust Washer
Burnish	Dull	NR
Wear	7	8
Rippling	10	NR
Ridging	10	NR
Pitting	9	NR
Spalling	10	NR
Scoring	10	NR
Discoloration	9	9
Corrosion	10	NR

The front axle spider gear exhibited no rippling, ridging, spalling, scoring or corrosion. AMSOIL 75W-90 Long Life Synthetic Gear Lube also controlled wear to a *light* level. The thrust washer earned a high merit rating for wear (*trace-light*), while discoloration was minimal.

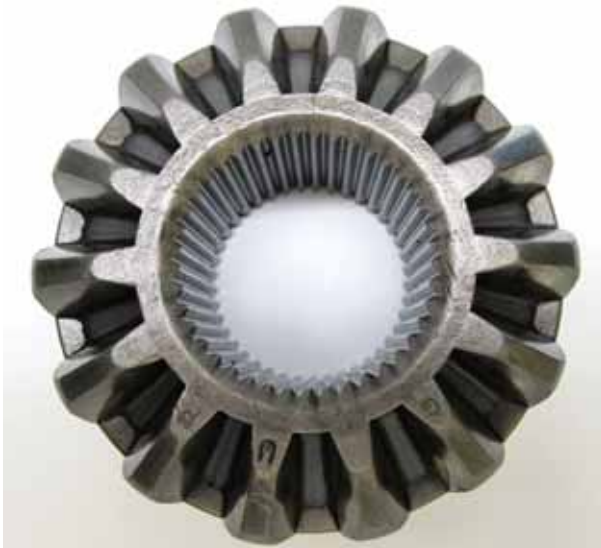
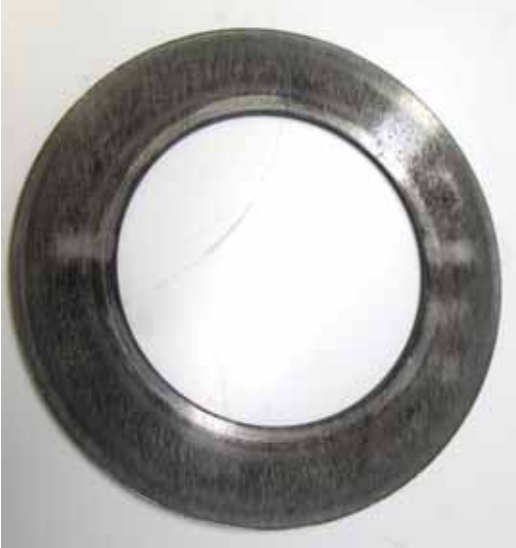
**Front Axle Side Gear & Thrust Washer**

Condition	Side Gear	Thrust Washer
<b>Burnish</b>	Medium Bright	NR
<b>Wear</b>	7	8
<b>Rippling</b>	10	NR
<b>Ridging</b>	10	NR
<b>Pitting</b>	10	NR
<b>Spalling</b>	10	NR
<b>Scoring</b>	10	NR
<b>Discoloration</b>	9	9
<b>Corrosion</b>	10	NR

The front axle side gear earned perfect 10 merit ratings in six of eight applicable categories, while wear was effectively inhibited to a *light* level, confirming the lubricant excelled in limiting metal-to-metal contact between meshing gear teeth. AMSOIL 75W-90 Long Life Synthetic Gear Lube also protected the thrust washer effectively.

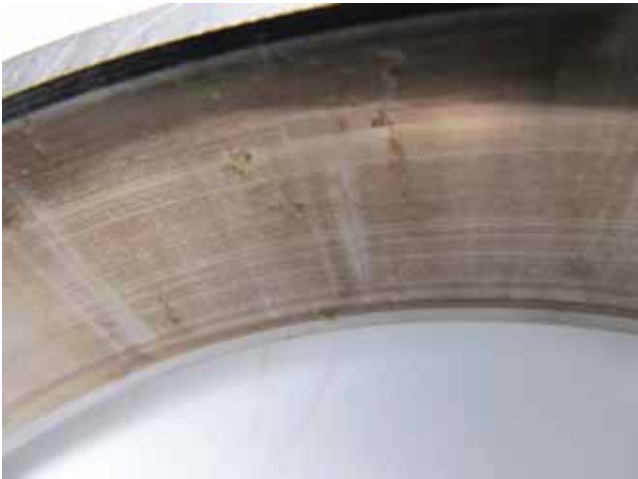
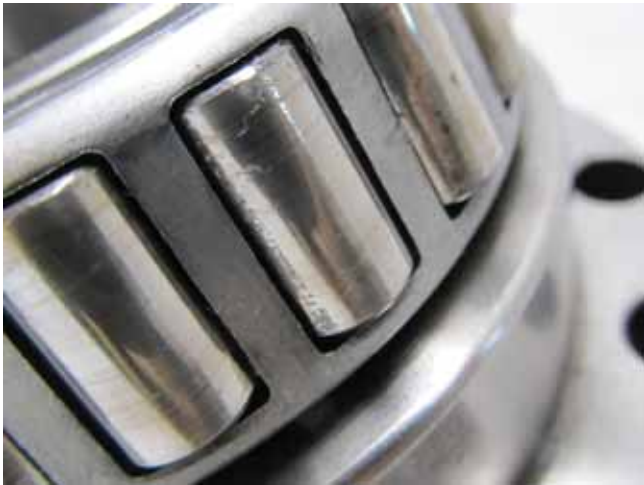
### Front Axle Differential Bearing

Condition	Cup	Rollers
Wear	8	8
Scoring	10	10
Pitting	8 <sup>1</sup>	8 <sup>1</sup>
Spalling	10	10
Discoloration	8	7
Corrosion	10	10
Roller End Wear	NR	7

<sup>1</sup>Debris denting, not pitting

In the areas of scoring, spalling and corrosion, the front axle differential bearing received perfect merit ratings of 10, indicating AMSOIL 75W-90 Long Life Synthetic Gear Lube provided superior bearing protection. The merit rating for wear is also high, indicating the strong protection the lubricant provided.

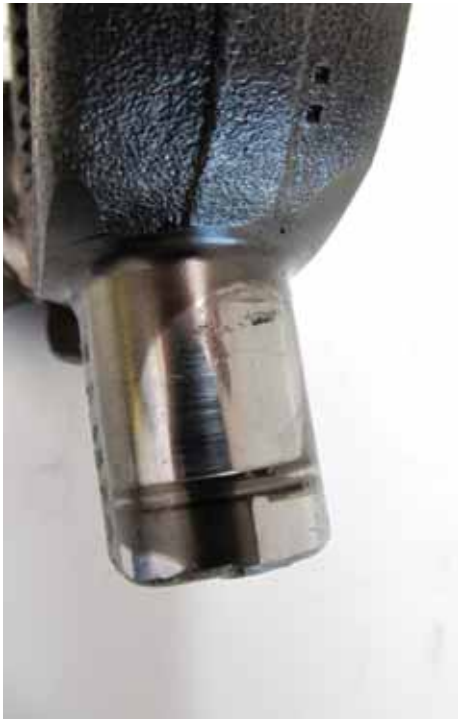
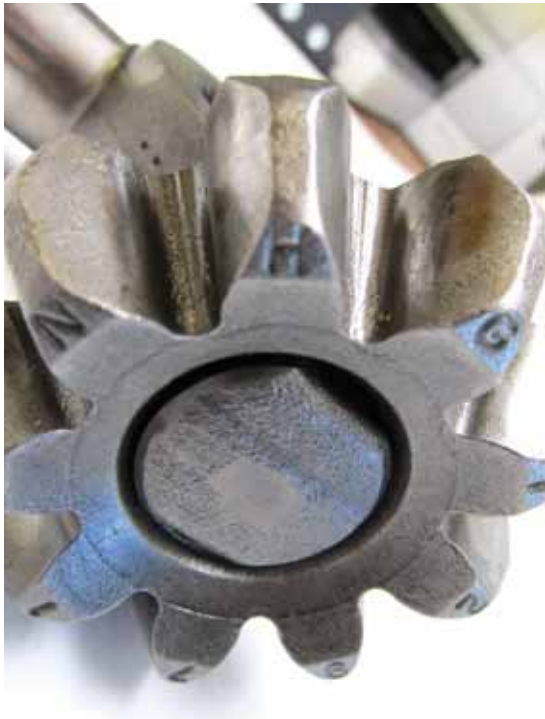
# Interaxle Differential Assembly

Condition	Cross Shaft	Spider Gear
Burnish	NR	Medium Bright
Wear	6	6
Ridging	7	NR
Pitting	8	5
Sludge	7	7

When the interaxle differential assembly is operating, it distributes torque equally to both the front and rear axles. Both the cross shaft and spider gear demonstrated *light-medium* wear. Ridging and pitting were likewise controlled to acceptable levels for a heavy-duty differential having accumulated over 500,000 miles.

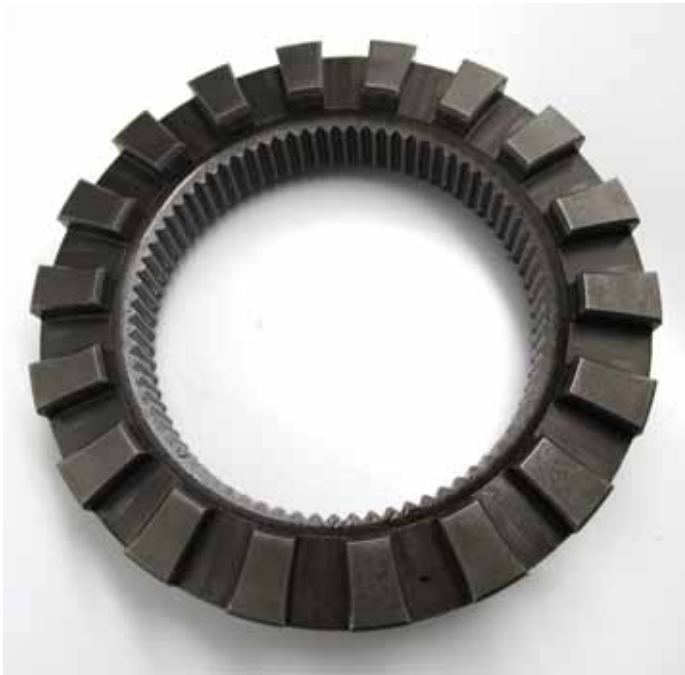
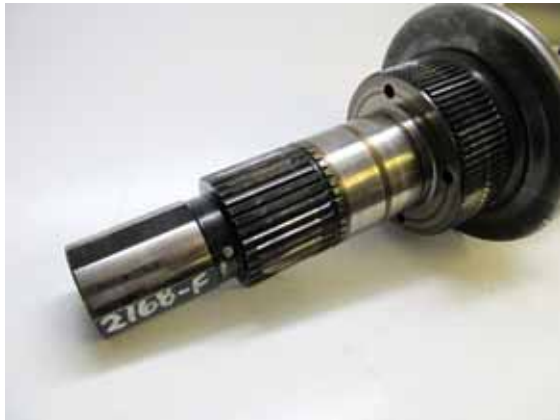
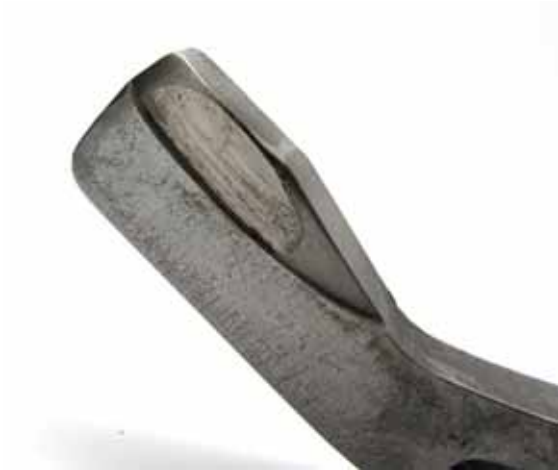
Front Axle Clutch Collar, Input Shaft & Shift Fork

Condition	Clutch Collar	Input Shaft	Shift Fork
Burnish	NR	Dull	NR
Wear	7	7	6
Sludge	6	6	7

The clutch collar bears friction repeatedly, representing a component prone to wear. Similarly, the shift fork undergoes frequent sliding motion and can be an area prone to metal-to-metal contact. AMSOIL 75W-90 Long Life Synthetic Gear Lube limited wear to a *light* level on the clutch collar and a *light-medium* level on the shift fork. The input shaft demonstrated *light* wear as well, confirming the lubricant's high level of protection.

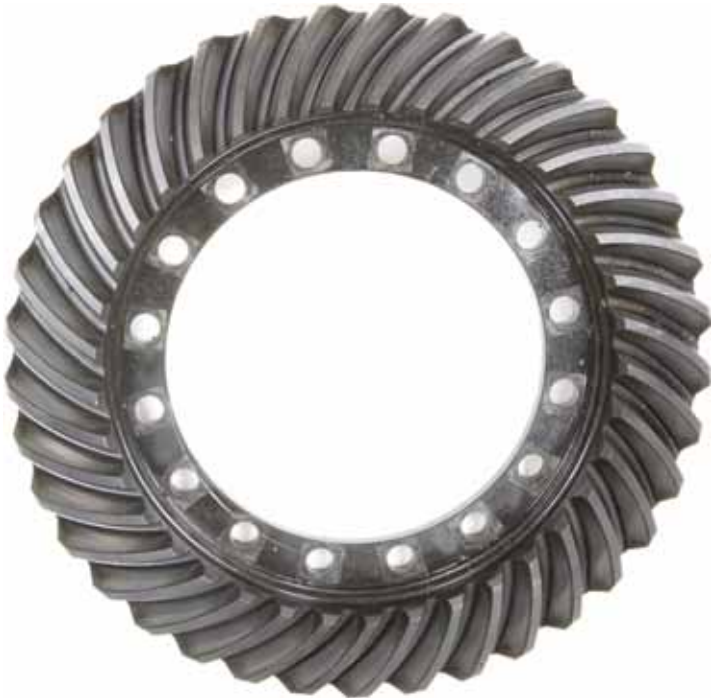
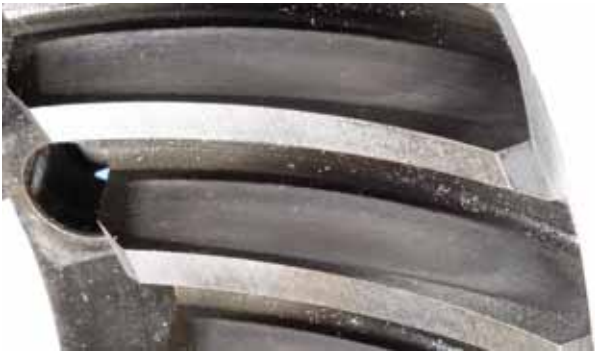
Rear Axle Ring Gear

Condition	Drive Side	Coast Side
Burnish	Dull	Dull
Wear	9	9
Rippling	10	10
Ridging	10	10
Pitting	10	10
Spalling	10	10
Scoring	10	10
Discoloration	9	9
Corrosion	10	10

The rear axle ring gear demonstrated *dull* burnish and earned perfect 10 merit ratings in six of eight applicable categories. The ring gear exhibited only a *trace* level of wear and discoloration despite the increased pressure and shock loading encountered when the rear differential is engaged. AMSOIL 75W-90 Long Life Synthetic Gear Lube provided excellent protection.

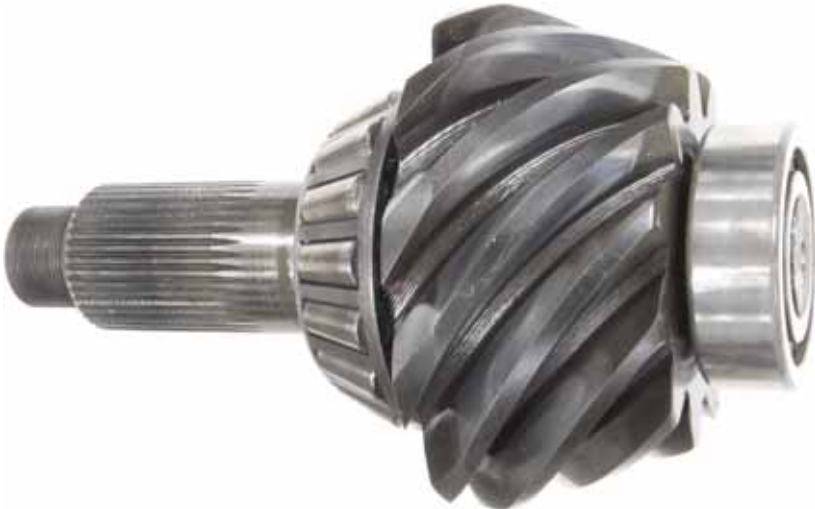
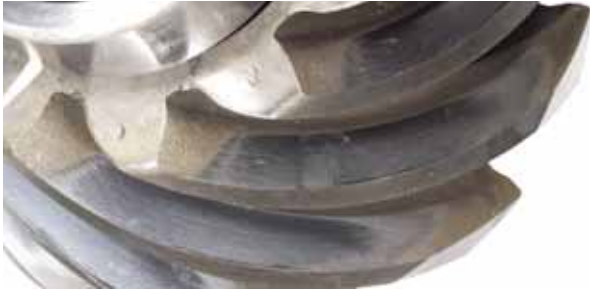
Rear Axle Pinion Gear

Condition	Drive Side	Coast Side
Burnish	Medium Bright	Medium Bright
Wear	8	8
Rippling	9	10
Ridging	10	10
Pitting	10	10
Spalling	10	10
Scoring	10	10
Discoloration	9	9
Corrosion	10	10

The rear axle pinion gear earned perfect 10 merit ratings in most categories, indicating the lubricant developed a strong lubricating film and inhibited distress. The gear ratio (3.36:1) indicates each pinion gear tooth engages in contact 3.36 times more often than each tooth on the mating ring gear. Given these conditions, the *medium bright* burnish rating is high, as is the *trace-light* wear rating.

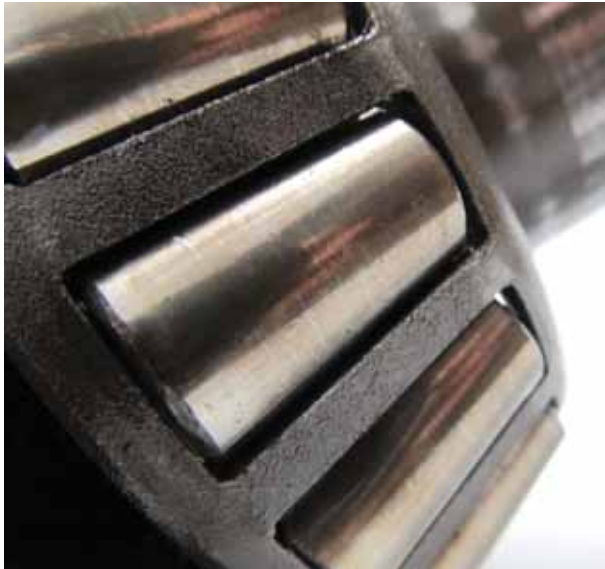
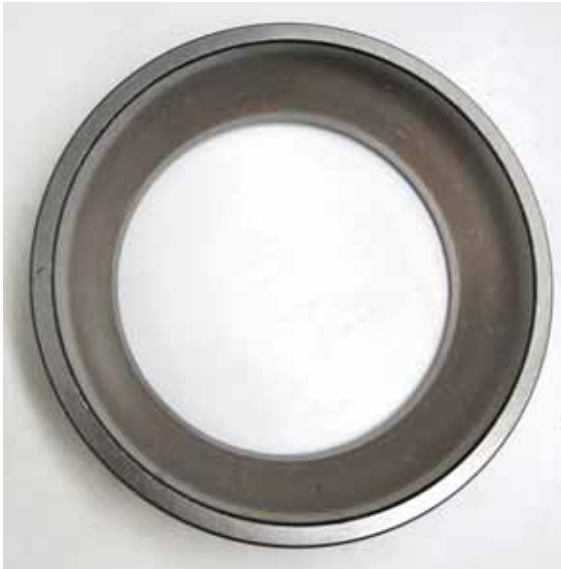
## Rear Axle Pinion Bearing

Condition	Cup	Rollers
Wear	8	8
Scoring	10	10
Pitting	8 <sup>1</sup>	8 <sup>1</sup>
Spalling	10	10
Discoloration	7	7
Corrosion	10	10
Roller End Wear	NR	7

<sup>1</sup>Debris denting, not pitting

The rear axle pinion bearing received excellent protection, earning perfect 10 merit ratings for scoring, spalling and corrosion. Despite elevated heat and rotational stress, pitting and wear were limited to *trace-light* levels, confirming the lubricant maintained protection throughout the service interval.

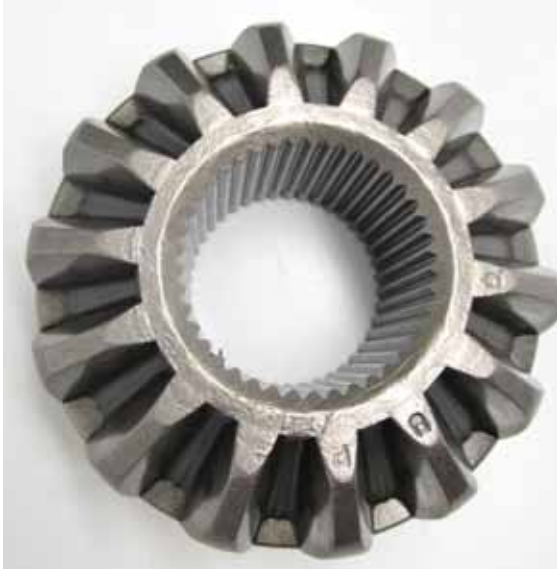
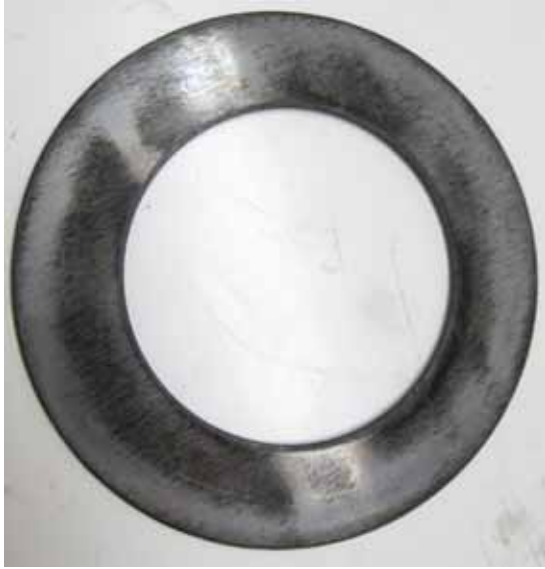
Rear Axle Side Gear & Thrust Washer

Condition	Side Gear	Thrust Washer
Burnish	Bright	NR
Wear	7	8
Rippling	10	NR
Ridging	10	NR
Pitting	10	NR
Spalling	10	NR
Scoring	10	NR
Discoloration	9	9
Corrosion	10	NR

The rear axle side gear received perfect 10 merit ratings in six of eight applicable categories, indicating the high level of protection the lubricant provided. Wear was controlled to a *light* level. The thrust washer exhibited *trace-light* wear, confirming the protection provided by the lubricant.

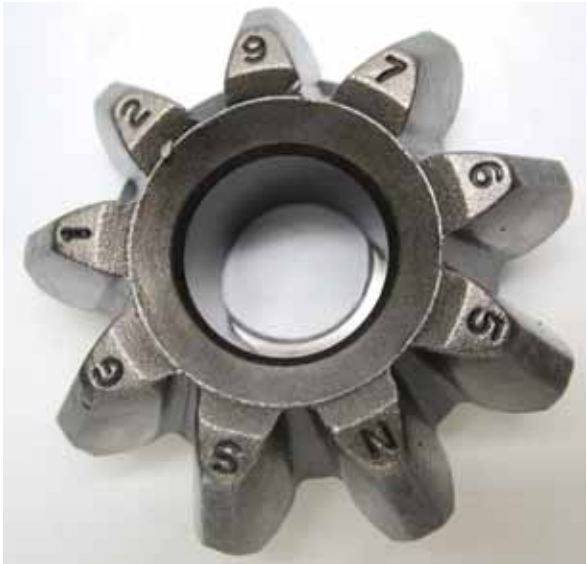
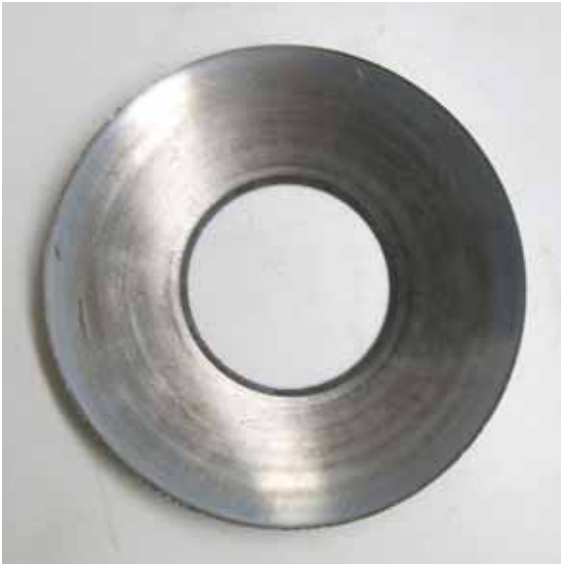
Rear Axle Spider Gear & Thrust Washer

Condition	Spider Gear	Thrust Washer
Burnish	Dull	NR
Wear	7	8
Rippling	10	NR
Ridging	10	NR
Pitting	10	NR
Spalling	10	NR
Scoring	10	NR
Discoloration	9	9
Corrosion	10	NR

Burnish on the spider gear was inhibited to a *dull* level, while the gear received perfect merit ratings for rippling, ridging, pitting, spalling, scoring and corrosion. The lubricant limited wear to *light* levels. The thrust washer demonstrated only *trace-light* wear.

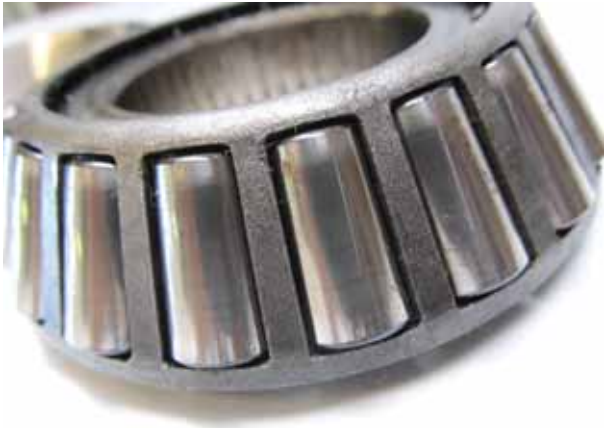
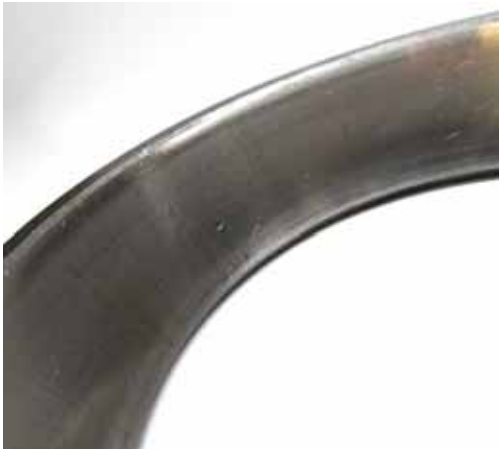
**Rear Axle Differential Bearing**

Condition	Cup	Rollers
<b>Wear</b>	8	8
<b>Scoring</b>	10	10
<b>Pitting</b>	6 <sup>1</sup>	7 <sup>1</sup>
<b>Spalling</b>	6	10
<b>Discoloration</b>	6	7
<b>Corrosion</b>	10	10
<b>Roller End Wear</b>	NR	7

<sup>1</sup>Debris denting, not pitting

AMSOIL 75W-90 Long Life Synthetic Gear Lube prevented scoring and corrosion to the rear axle bearing. The rollers likewise demonstrated no spalling, confirming the lubricant provided a high level of protection. Wear was inhibited to a *trace-light* level on both the cup and rollers.

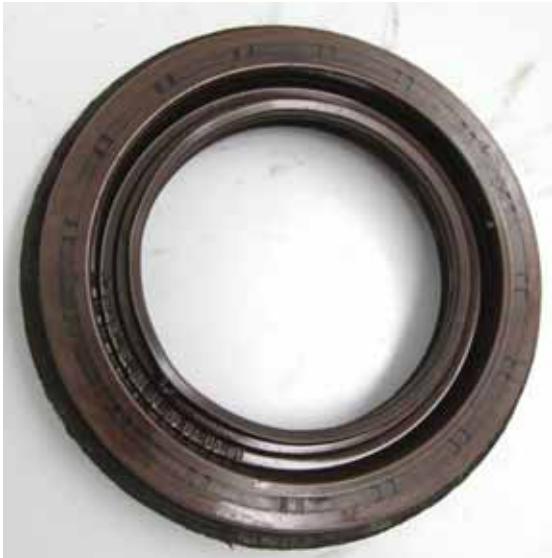
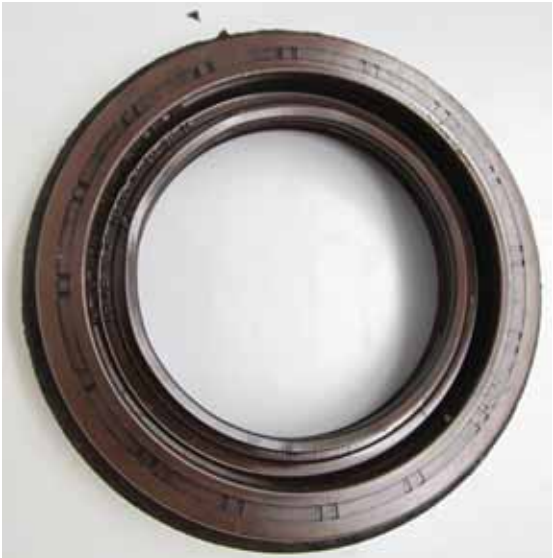
**Front & Rear Axle Seals**

Condition	Front Seal	Rear Seal
Wear	9	6
Hardening	10	10
Reversion	10	10
Blistering	10	10
Cracking	10	10
Deposits	9	9

Both the front and rear axle seals earned perfect merit ratings for hardening, reversion, blistering and cracking. Deposits were limited to *trace* levels, while the front seal demonstrated only a *trace* level of wear. Results confirm AMSOIL 75W-90 Long Life Synthetic Gear Lube’s ability to provide excellent protection for seals.

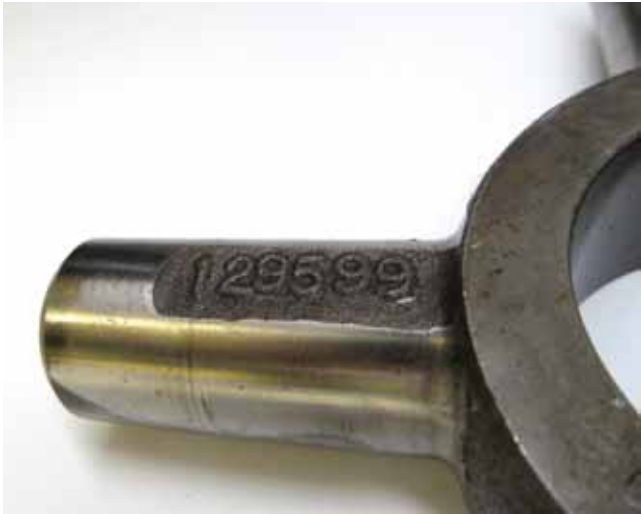
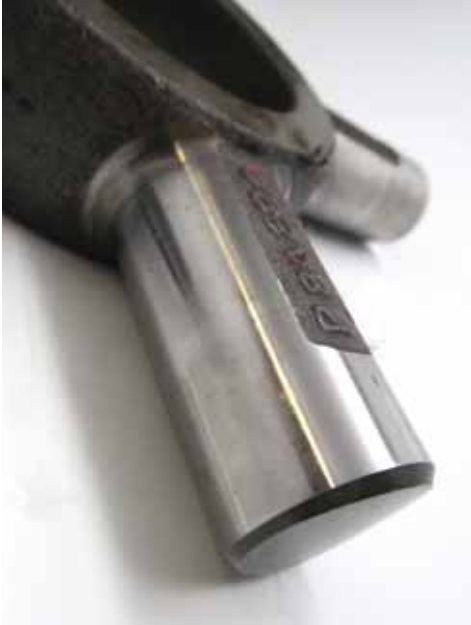
**Front & Rear Axle Cross Shafts**

Condition	Front Cross Shaft	Rear Cross Shaft
Burnish	Bright	Bright
Wear	8	8
Rippling	10	10
Ridging	10	10
Pitting	9	10
Spalling	10	10
Scoring	10	10
Discoloration	9	9
Corrosion	10	10

The spider gears rotate on the cross shafts, which are subject to shock loading and rotational stress. Both front and rear cross shafts earned perfect merit ratings for rippling, ridging, spalling, scoring and corrosion. The lubricant limited wear to *trace-light* levels, demonstrating its strong protective properties.
